Product Usage Guidelines for Corrugated Steel Pipe

Environmental Guidelines for Corrugated Steel Pipe

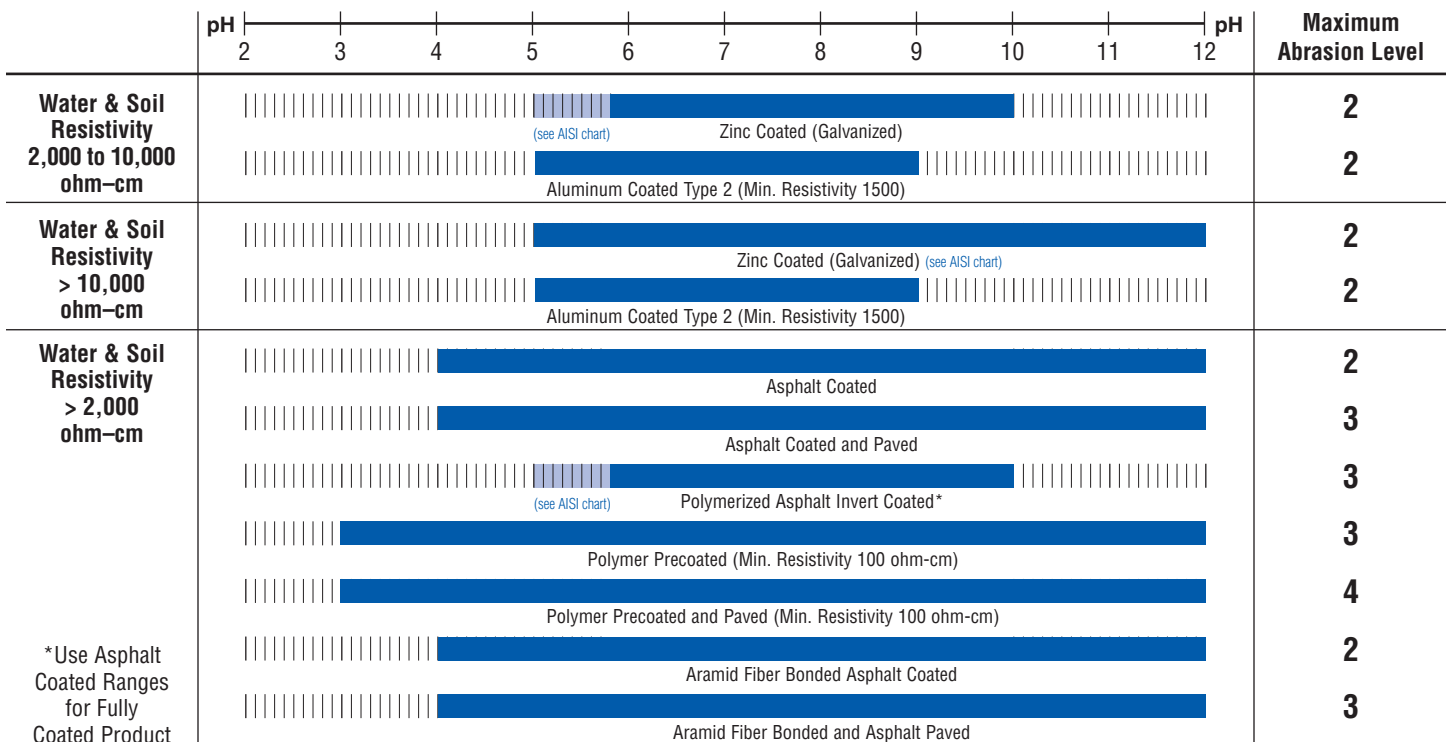
- **Normal Conditions:** pH = 5.8 – 8.0 (for R > 2000 ohm-cm)
- **Mildly Corrosive:** pH = 5.0 – 5.8 and/or for R = 1500 to 2000 ohm-cm
- **Corrosive:** pH < 5.0 (for R < 1500 ohm-cm)

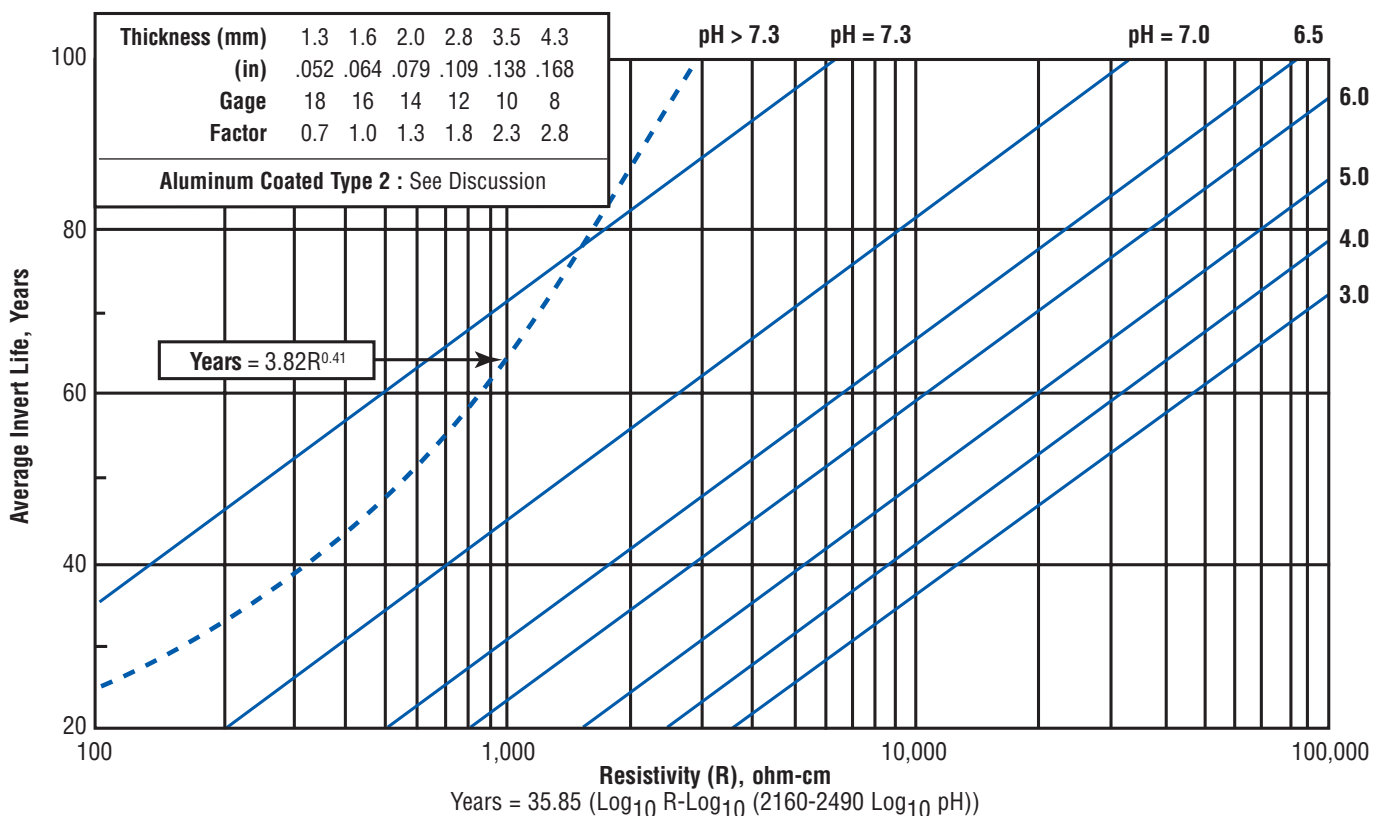
AISI Chart for Estimating Average Invert Life for Galvanized CSP

- 1) Locate on the horizontal axis the soil resistivity (R) representative of the site.
- 2) Move vertically to the intersection of the sloping line for the soil pH. If pH exceeds 7.3 use the dashed line instead.
- 3) Move horizontally to the vertical axis and read the service life years for a pipe with 1.6 mm (0.064 in.) wall thickness.
- 4) Repeat the procedure using the resistivity and pH of the water; then use whichever service life is lower.
- 5) To determine the service life for a greater wall thickness, multiply the service life by the factor given in the inset on the chart.

The service life of zinc coated galvanized is determined using the AISI Chart on page 4. This chart predicts a variable service life based on pH and resistivity of water and soil and has been an industry standard for many years. Many specifying agencies view service life of aluminum coated type 2 as having additional service life over galvanized.^{4,5,6,7} This advantage varies throughout the country from minimal to significant depending on the environment and the geographic location. Users are encouraged to review the practices in their area.

The service life of CSP can be reasonably predicted based on the environmental conditions, the thickness of the steel, and life of the coating. The most practical method of predicting the service life of the invert is with the AISI (American Iron and Steel Institute) chart shown on page 4.⁹ This chart is based on 16 gage galvanized CSP with a 610 g/m² (2 oz/ft²) coating and can be applied to other thicknesses with the appropriate factor. See discussion above for estimating the service life of aluminum coated type 2.

The AISI chart, which gives service life in terms of resistivity and pH, was developed from a chart originally prepared by the California Department of Transportation (Caltrans).¹⁰ The Caltrans study of durability was based on life to first perforation in culverts that had not received any special maintenance treatment. The results included the combined effects of soil-side and interior corrosion, as well as the average effects of abrasion. For pipes where the pH was greater than 7.3, soil-side corrosion controlled and life could be predicted by resistivity. For pipes where the pH was less than 7.3, the interior invert corrosion generally controlled and both resistivity and pH were important. In the field inspection of 7000 culverts in California for Caltrans, Richard Stratfull, Lead Project

The consequences of small perforations are minimal in a gravity flow pipe such as most storm sewers and culverts and do not accurately reflect the actual service life. Because of this fact, the original curves were converted by Stratfull to average service life curves using data on weight loss and pitting in bare steel developed by the National Institute of Standards and Technology. Since storm sewers and culverts are usually designed with a structural safety factor of at least 2.0, a significant safety factor of 1.5 remains at the end of the service life predicted by the chart. Thus, use of the chart is considered reasonably conservative. The Caltrans Method may be appropriate for use under pressure applications. Where service life is controlled by invert performance, rehabilitation of the invert at the end of the predicted life can extend service life significantly.

The durability design chart can be used to predict the service life of galvanized CSP and to select the minimum thickness for any desired service life. Add-on service life values are provided in the table on page 5 for additional coatings.

Additional service life can be provided by increasing the thickness of the base steel in accordance with the factors shown in the Chart for Estimating Average Invert Service Life or with the use of additional coating systems. Add-on service life values are provided in the Tables on page 5.
